VW Lupo Window Regulator Cog

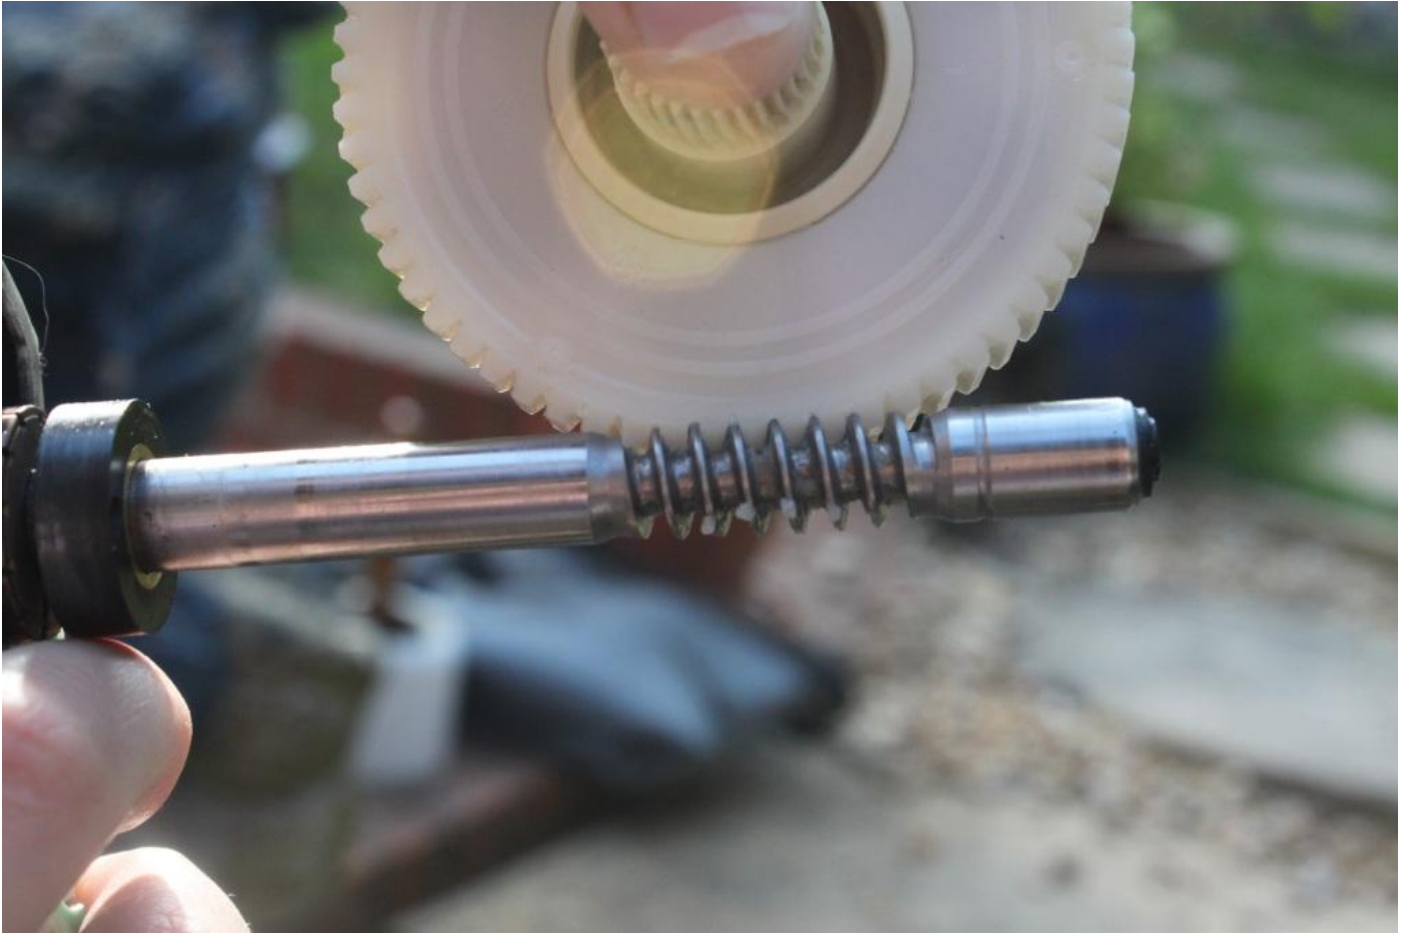
As you can see in the below picture the motor spindle fits nicely into the motor cog

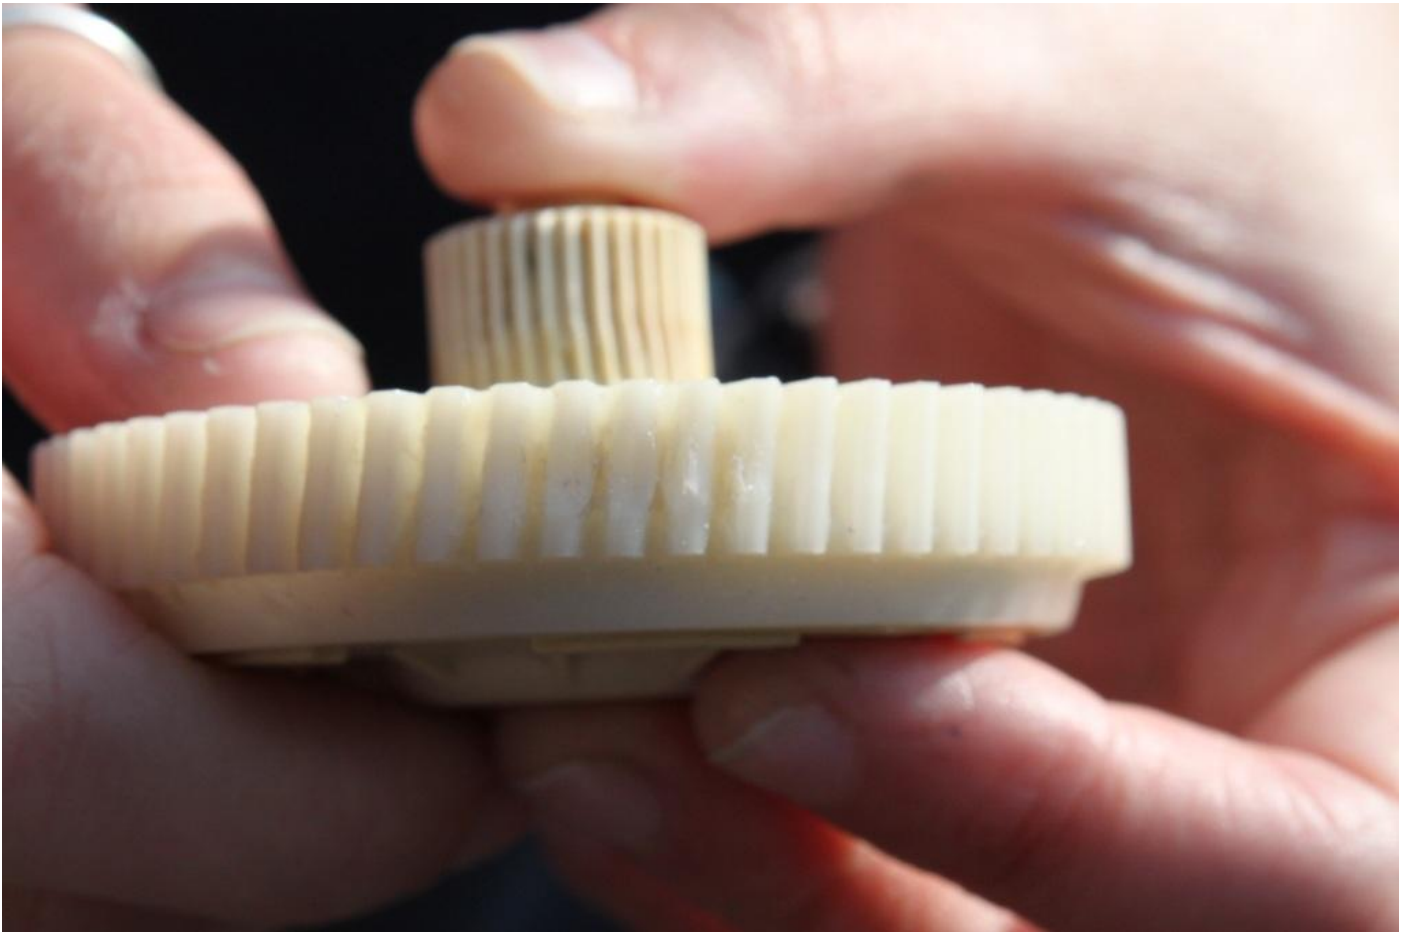
On the other side of my regulator cog there are a few cogs which has been flattened and I believe this to be the cause of the electric window just clicking and not operating.

If you look at the picture below, you'll see what I mean about the flattened cogs

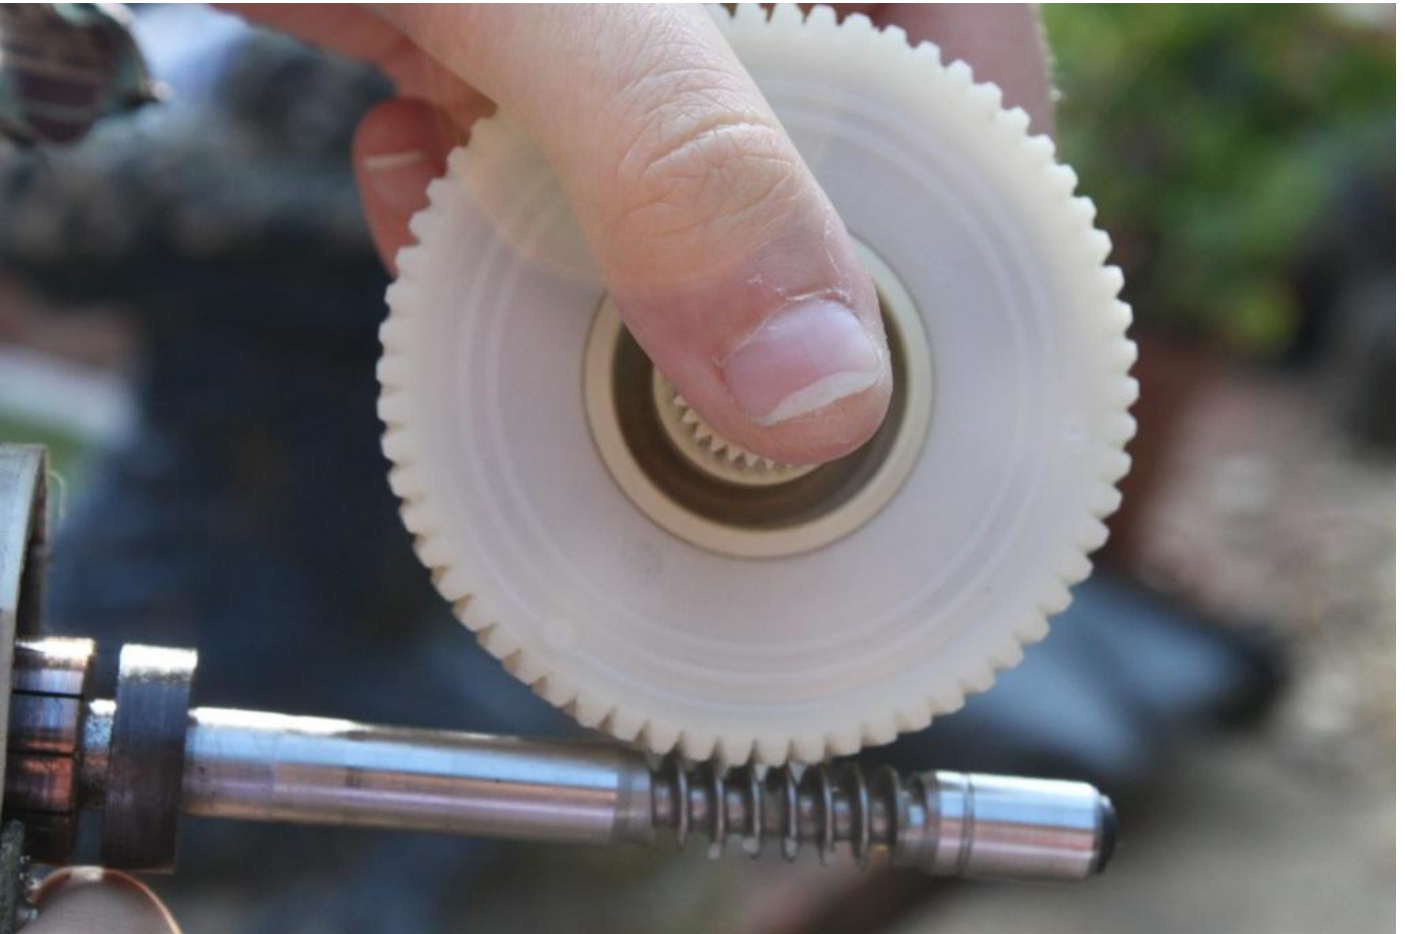
Because of this, you'll see the motor spindle not engaging correctly

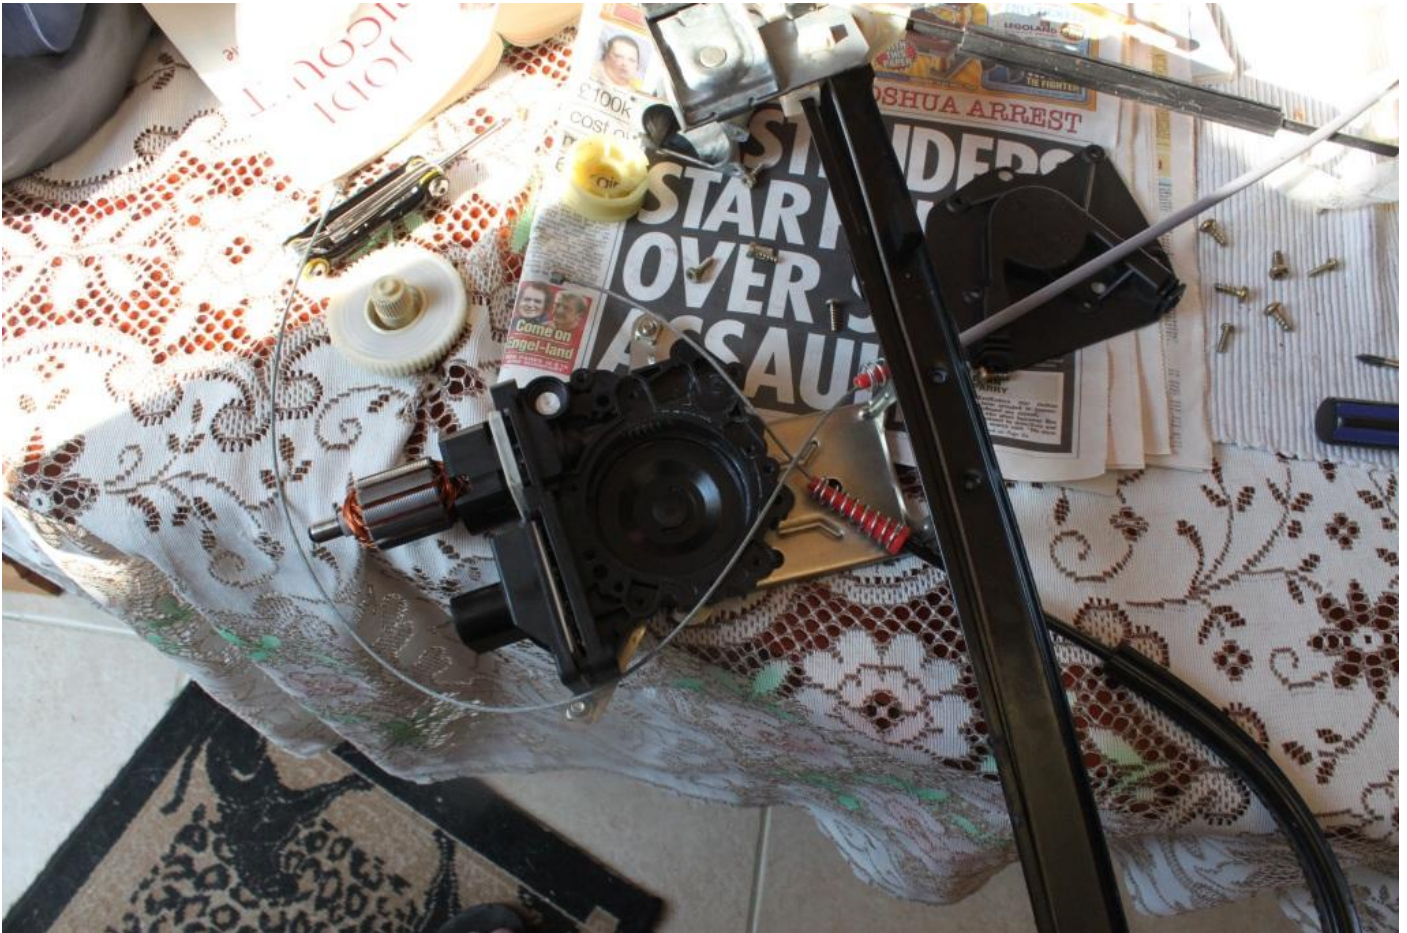
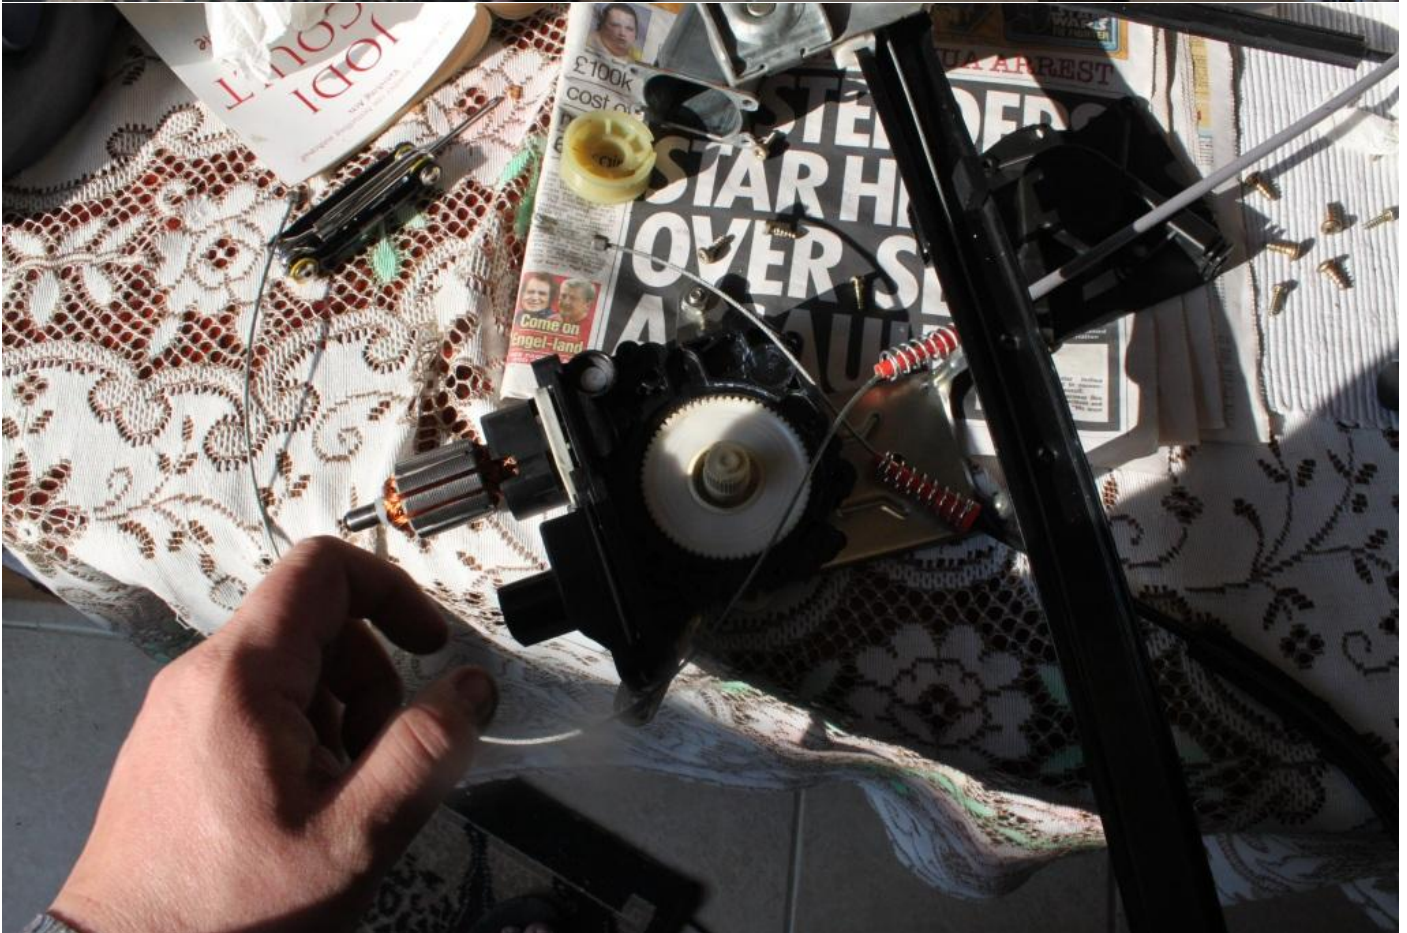
The next two photos are where the parts sit within the motor section
